# Manhole Inspection Summary

Manhole # S25A\_\_042MH

Insp Date: **11/27/07 1:16 PM**

**Location** Address: **1116 HARLEM AVE**

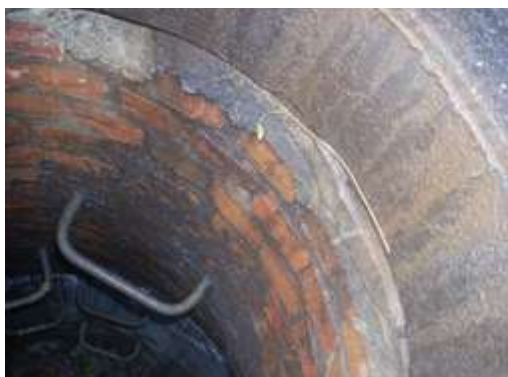
Defect 1

**Corbel** Material: **Brick** ☐ Parged Type: **Concentric/Eccentric**  
Condition: ☒ Sound ☐ Cracked ☐ Root Intrusion ☐ Loose Brick ☐ Deteriorated  
Infiltration: ☐ None ☐ Joint ☐ Cracks ☐ Mortar ☐ Roots ☒ Wall

CORBEL INFILTRATION

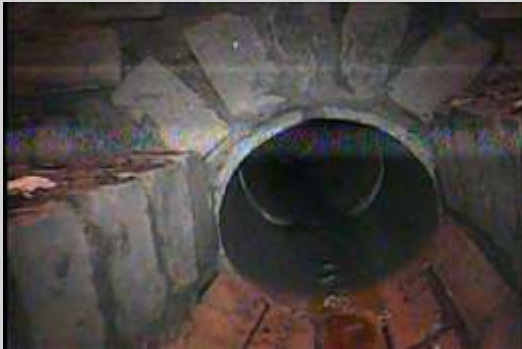
12 O'Clock Outflow

8 in. Circular Gravity Sewer  
Pipe Out @ 12 O'Clock

Pipe Height: **7.2** (in.) Rod and Bar (Angled)  
Pipe Material: **Clay** ☐ Pipe Lined  
Invert Depth: **10.71** (ft.) Flow Characteristics: **Slow**  
Deposits: ☒ None ☐ Mud ☐ Sludge ☐ Debris ☐ Grease  
Silt Depth: (in.) Deposits Extent:  
Infiltration: **None** Pipe Seal Cond: **Sound**

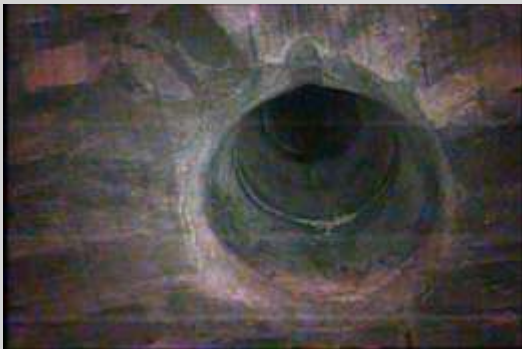
9 O'Clock Inflow

8 in. Circular Gravity Sewer  
Pipe In @ 9 O'Clock

CORBEL INFILTRATION

Pipe Height: **8.4** (in.) Rod and Bar (Angled)  
Pipe Material: **Clay** ☐ Pipe Lined  
Invert Depth: **7.92** (ft.) Flow Characteristics: **Slow**  
Deposits: ☒ None ☐ Mud ☐ Sludge ☐ Debris ☐ Grease  
Silt Depth: (in.) Deposits Extent:  
Infiltration: **None** Pipe Seal Cond: **Sound**

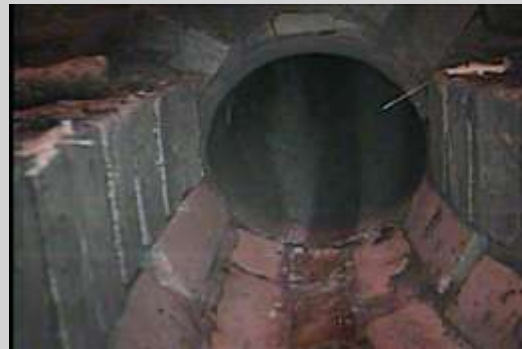
Drop In @ 9 O'Clock

CORBEL INFILTRATION

Drop: **Outside** Rod and Bar  
Angled: **Yes** Reading: **8.59** (ft.)  
Inv Depth: **9.59** (ft.)

Drop Condition: **Open**
